The Most Cut-Resistant Neck Guard for Preventing Lacerations to the Neck

Objective: To evaluate the effectiveness of a variety of neck guard brands when contacted by a sharpened hockey skate blade.

(*Clin J Sport Med* 2014;0:1–6)

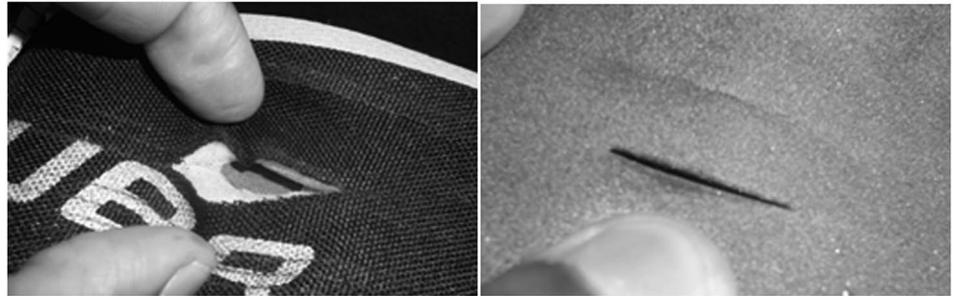
FIGURE 3. Example of a neck guard failure due to 300 N at a blade angle of 45 degrees and blade speed of 5 m/s. The figure on the left shows a Bauer N7 Nectech that failed 2 of its 4 tests. It was the only neck guard to fail low force tests. The injured foam is on the right.

Any foam laceration was noted as a failure to protect for the neck guard (Figure 3). Damage to the neck guard or device injury was defined as a laceration to the outer surface of the neck guard. Nominal logistic regression was used to analyze results of the low-force tests using the outcomes of damage to the foam or device injury to the protector. Independent variables for each nominal logistic regression were angle, force, neck guard type, and sample. The significant level was set at $P < 0.05$. For the high-force tests, the definitions for neck guard failures were the same as in the low-force tests. The number of failed neck guards was compared directly with the number of neck guards that did not fail.

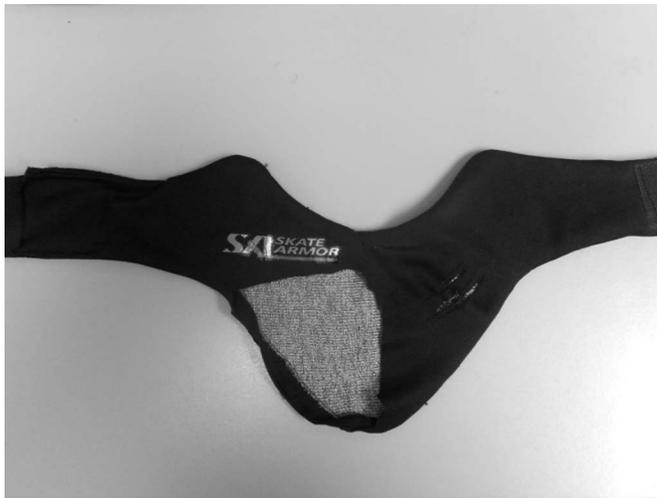
FIGURE 5. A skate armor neck guard with the spectra fibers showing. Spectra fibers have higher tensile strength and modulus of elasticity than Kevlar fibers.

The Reebok 11K and Skate Armor neck guard were the only 2 brands that did not consistently fail at 600 N. The Reebok 11K and Skate Armor prevented failure for 33% and 100% of times tested at the 600 N, respectively. Both neck guards had designs distinct from all other neck guards tested. The Reebok 11K had 2 layers of Kevlar, which decreased the probability of neck guard failure (damage to the foam). The Skate Armor neck guard was the only neck guard that incorporated Spectra Guard as its protective inner fabric (Figure 5). The Spectra fibers of the neck guard have a higher modulus of elasticity and tensile strength than Kevlar (Figure 6).^{9,10} Added strength and stiffness from Spectra fibers contributed to the cut resistance throughout testing.
